APPENDIX A

Criteria & Implementation Procedures for Valley & Stream
Corridor Regeneration and Remedial Works Projects

PHOTOGRAPH LOCATION AND PHYSICAL FEATURES PLAN

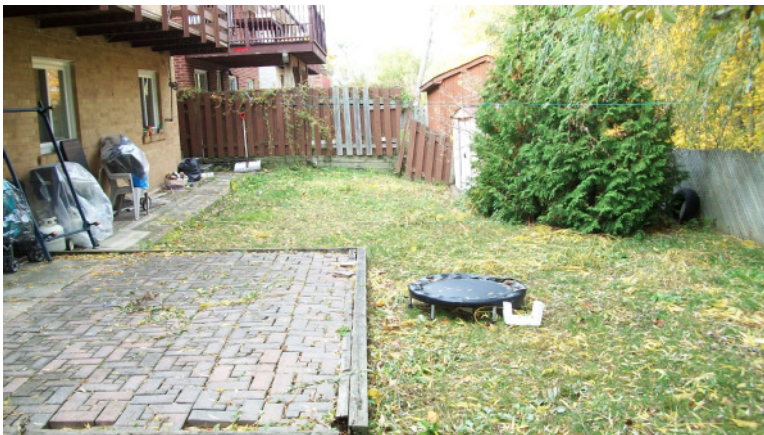
PHOTOGRAPH No.5

Tableland and slope crest of 37 Troutbrooke Dr., failed fence in background, looking west.

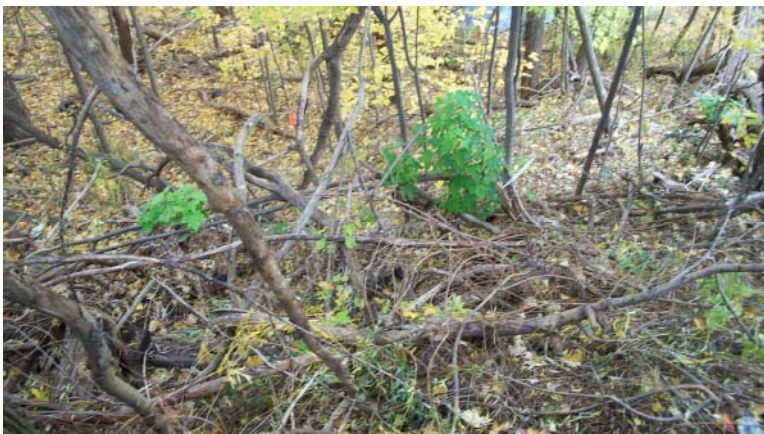
PHOTOGRAPH No.6

Slope face directly north of 37 Troutbrooke Dr., landscape debris present, looking north.

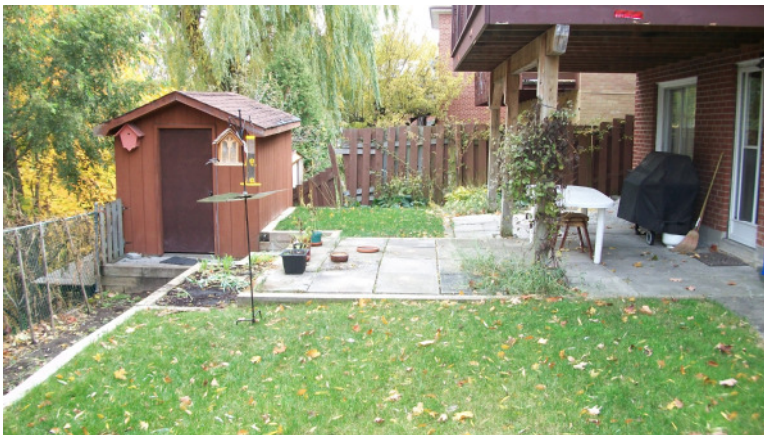
PHOTOGRAPH No.8
Tableland and slope crest of
39 Troutbrooke Dr., failed fence
in background, looking east.

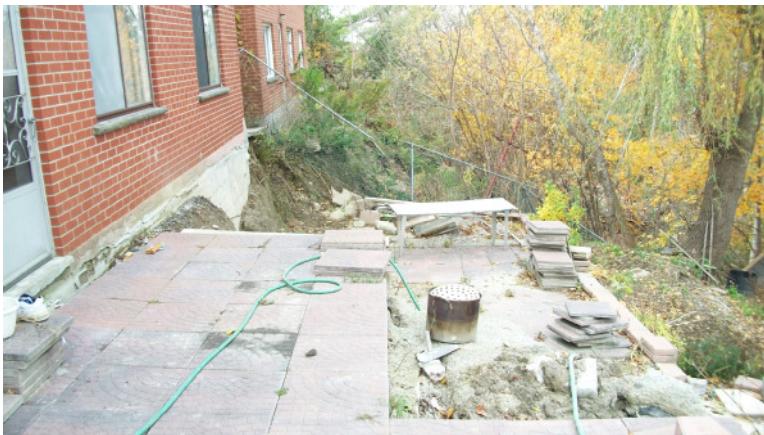
PHOTOGRAPH No.17
Tableland and slope crest of
45 Troutbrooke Dr., destruction
of tableland due to slumping
and exposed foundation wall,
looking west.

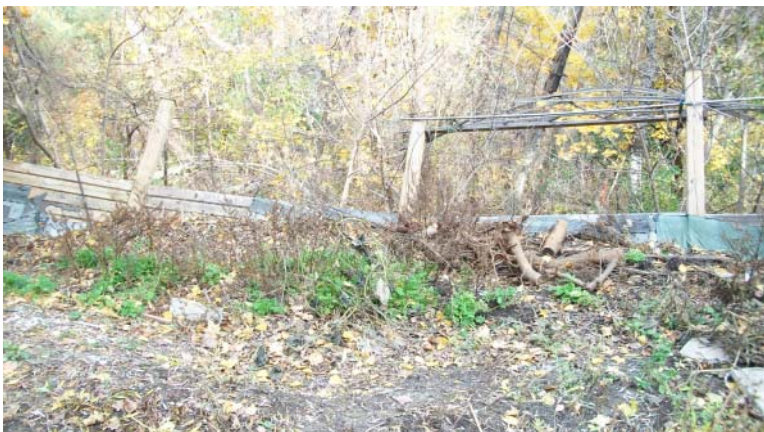
PHOTOGRAPH No.18
Slope face directly north of
45 Troutbrooke Dr., failed
retaining wall, looking north.

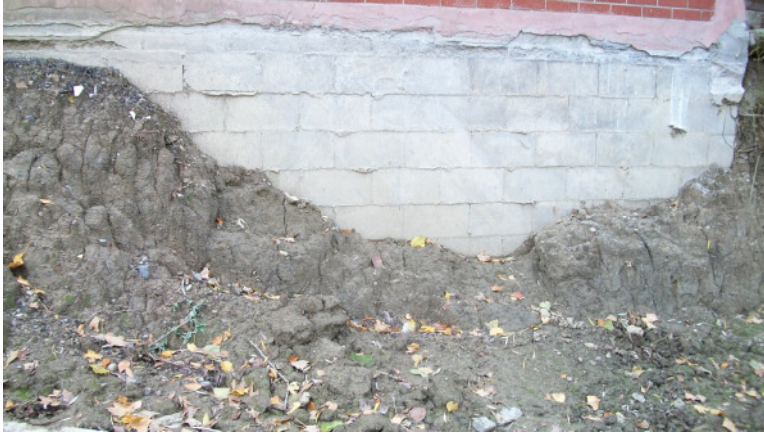
PHOTOGRAPH No.28

Exposed foundation present directly north of 45 Troutbrooke Dr., looking south.

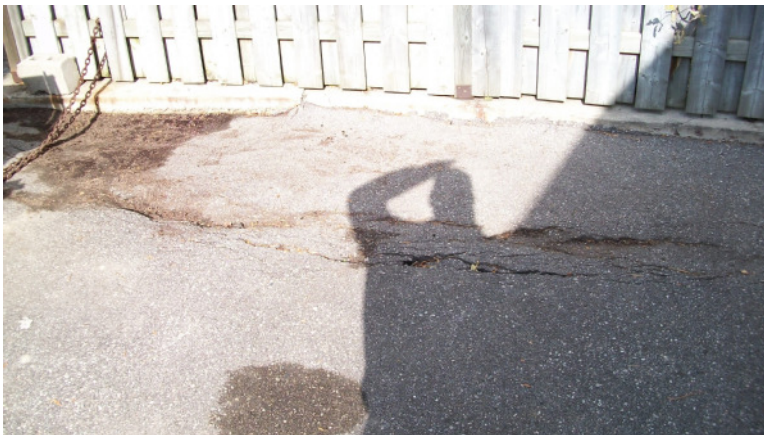
PHOTOGRAPH No.29

Tension cracking in pavement in between 49 and 51 Troutbrooke Dr., looking northwest.

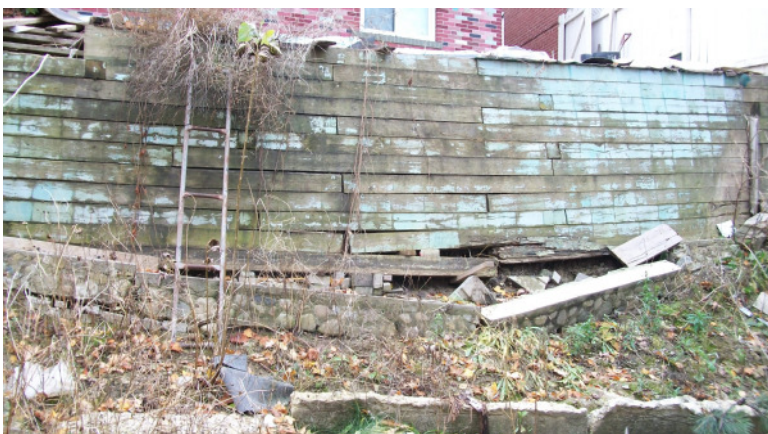
PHOTOGRAPH No.36

Failing retaining wall north of 43 Troutbrooke Dr., looking south.

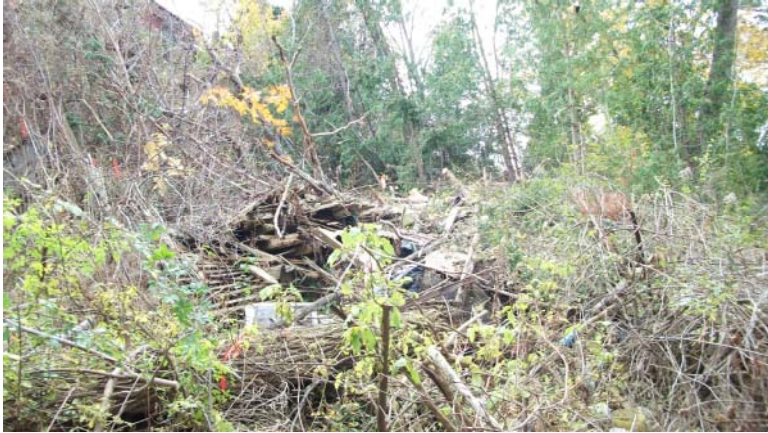
PHOTOGRAPH No.37

Extensive garbage and landscaping debris, looking southwest.
