Troutbrooke Slope Stabilization Project

Toronto and Region Conservation Authority
Project Plan

April 15, 2011

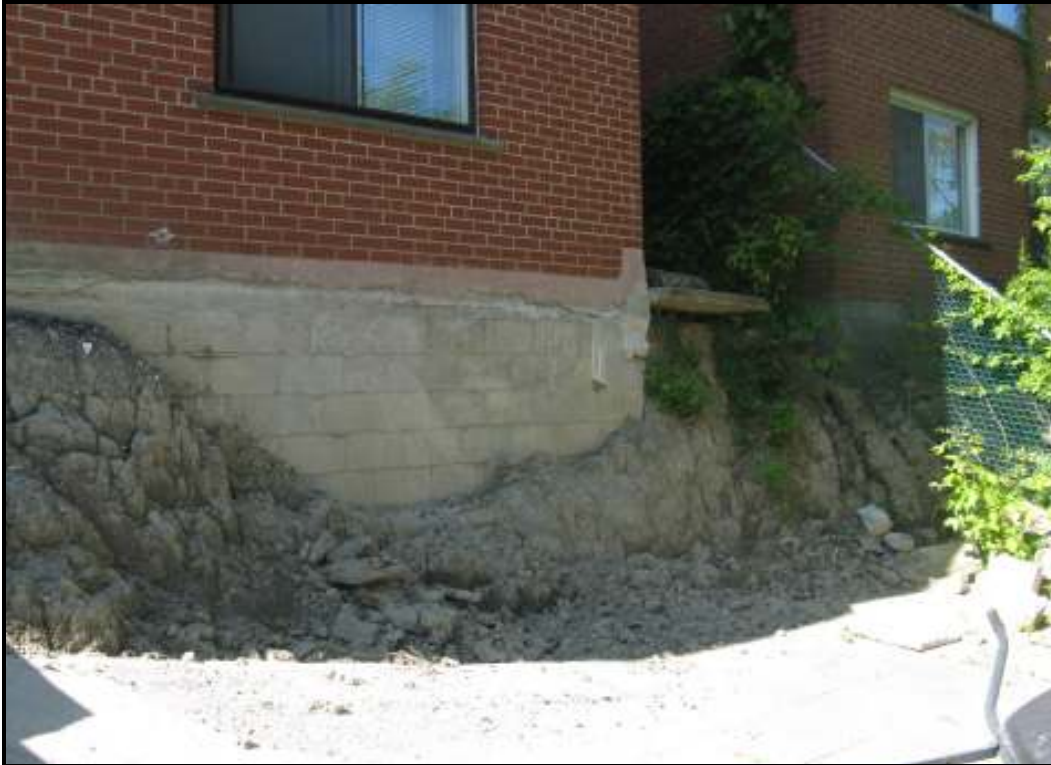
Figure 4. Active erosion exposed foundation at No. 45 Troutbrooke Drive.
Source: TRCA, 2009.

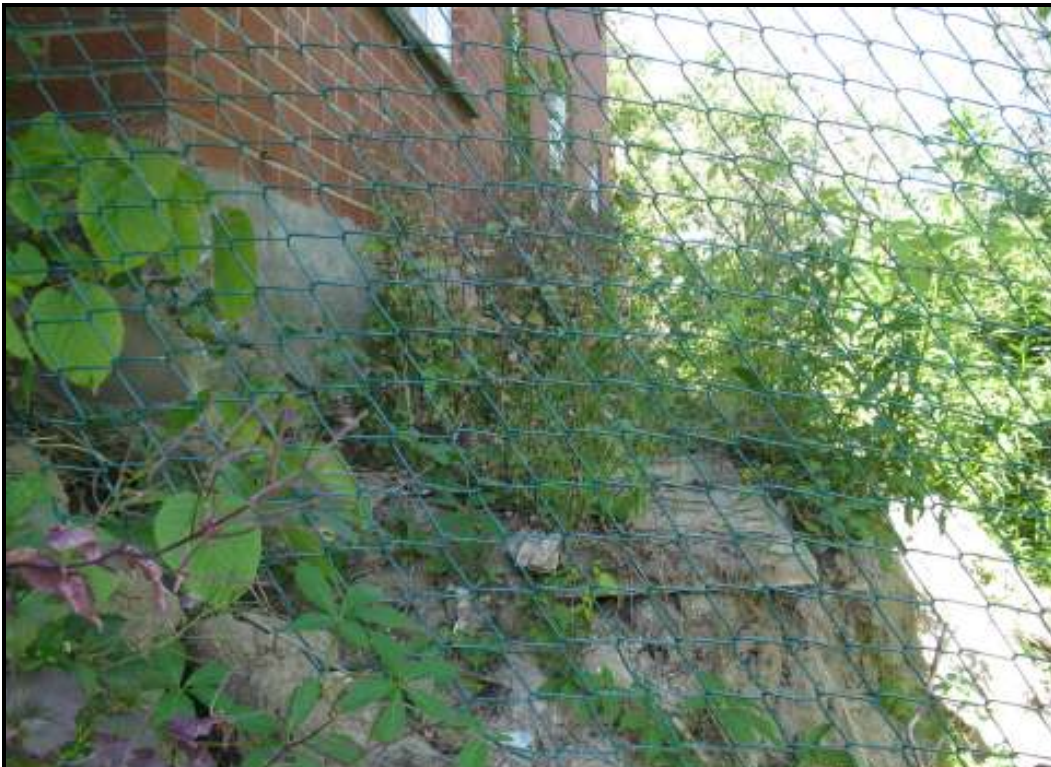
Figure 5. Active erosion exposing foundation at No. 47 Troutbrooke Drive.
Source: TRCA, 2009.

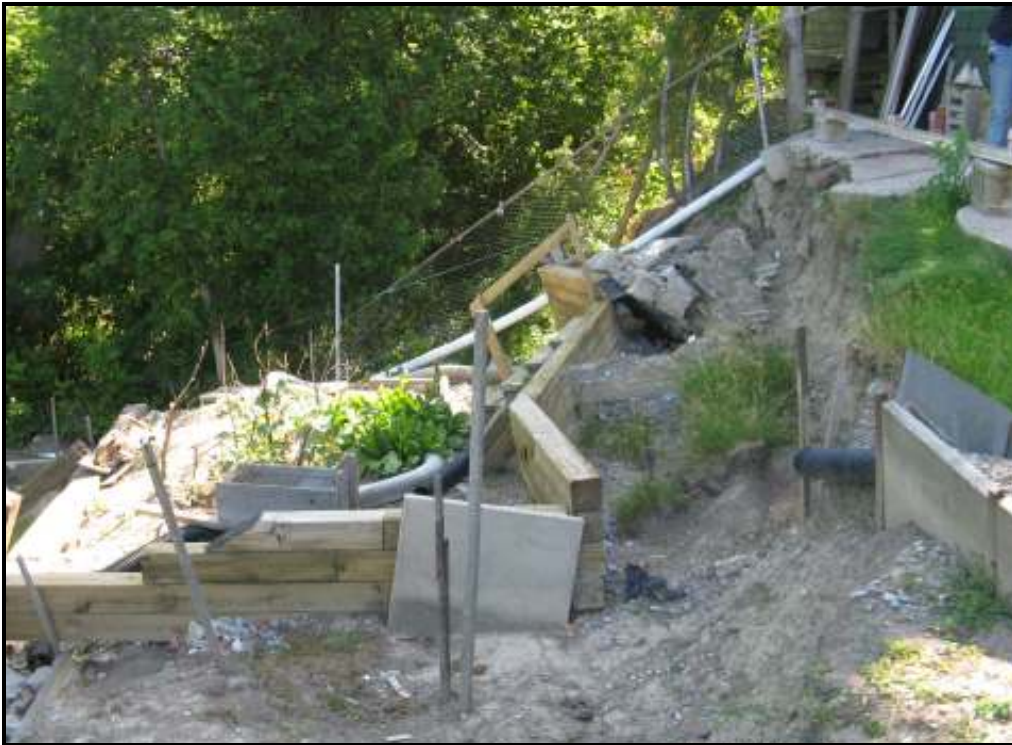
Figure 6. Failed retaining walls in the rear yard at No. 51 Troutbrooke Drive.
Source: TRCA, 2009.

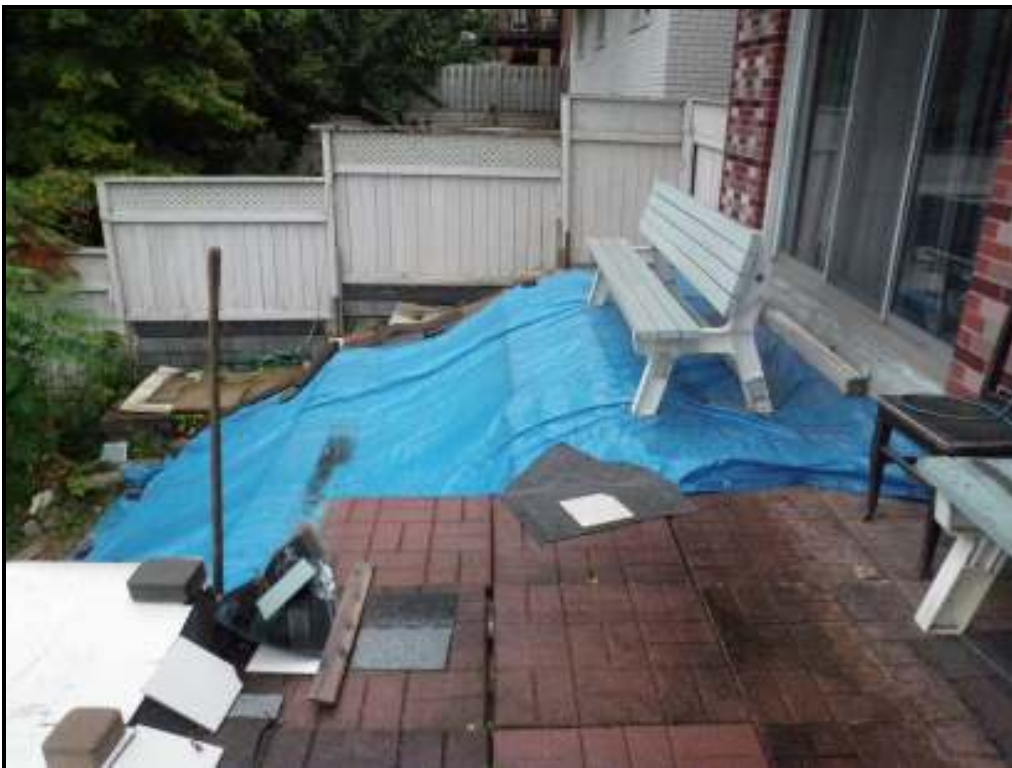
Figure 7. Active erosion in the rear yard at No. 43 Troutbrooke Drive.
Source: TRCA, 2010.

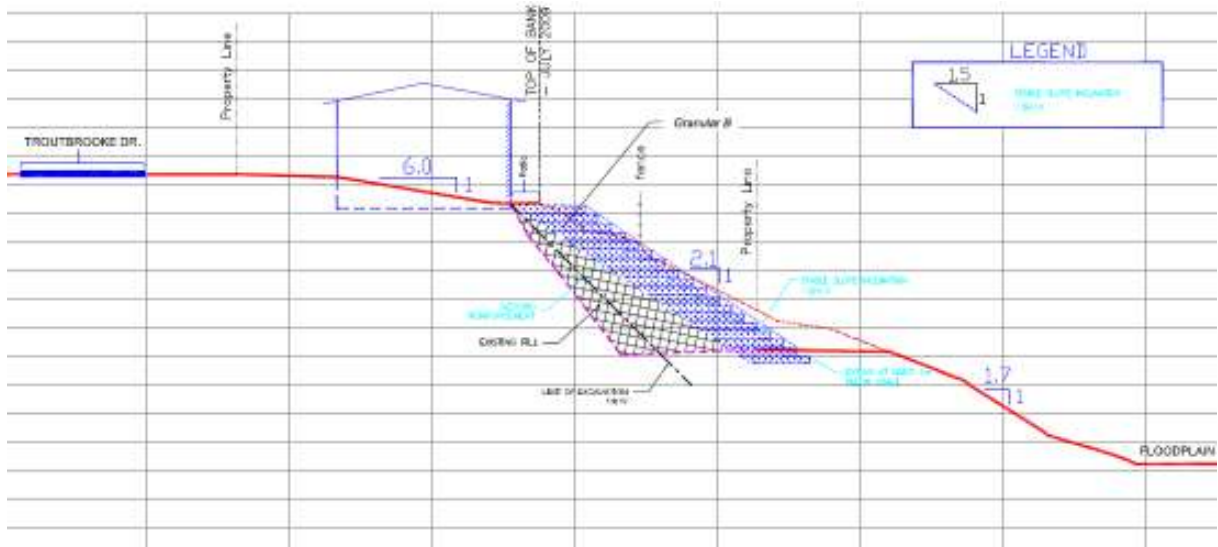
Figure 19. Concept 2C remove existing fill, dispose excavated fill, replace with compacted Granular “B” fill that is reinforced with geogrid (1.5 H: 1 V).
 Source: Terraprobe, 2011.

Each of the three variations of this concept are proposed at various inclinations, consequently, the volume of fill material to be removed and replaced is dependent on the variation. It should be noted that due to the inclination of Concept 2a (2.5 H: 1V), a berm will be required at the toe of the valley wall.

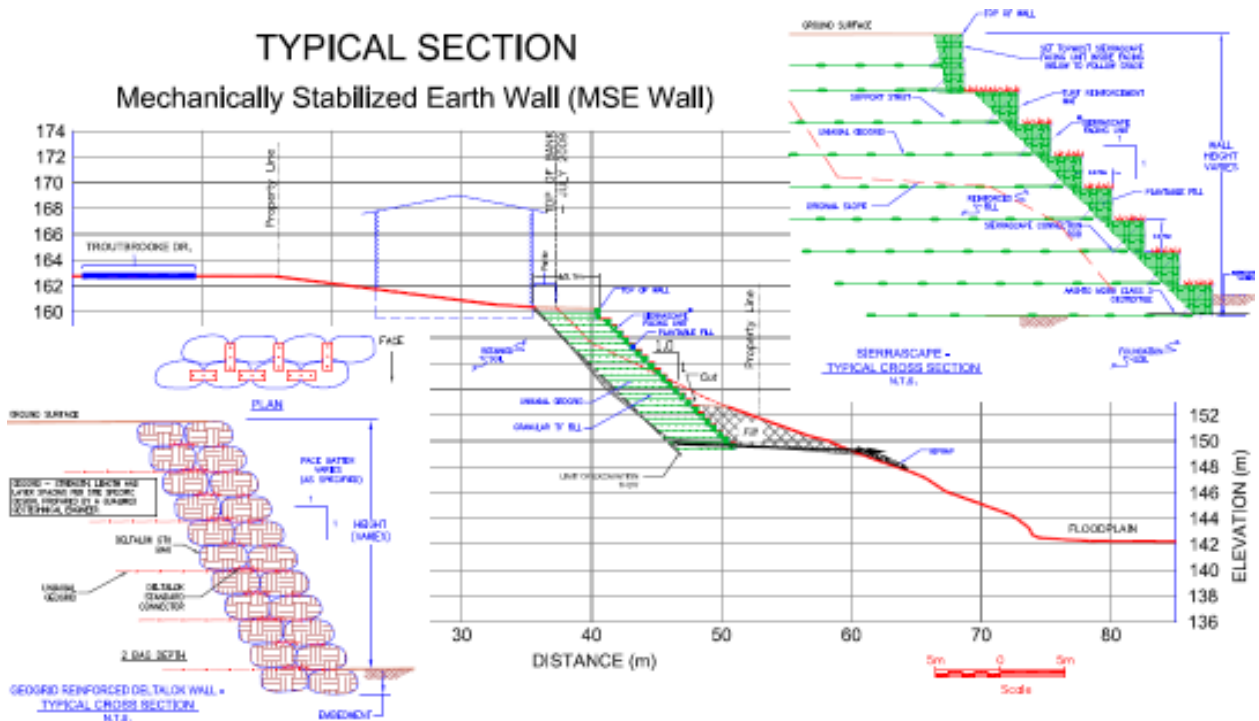
Figure 21. Concept 3 creates a minimum of 5 m of tableland or the identified 2009 Top of Bank.
Source: Terraprobe, 2011.
