APPENDIX A

Criteria & Implementation Procedures for Valley & Stream
Corridor Regeneration and Remedial Works Projects

PHOTOGRAPH LOCATION AND PHYSICAL FEATURES PLAN

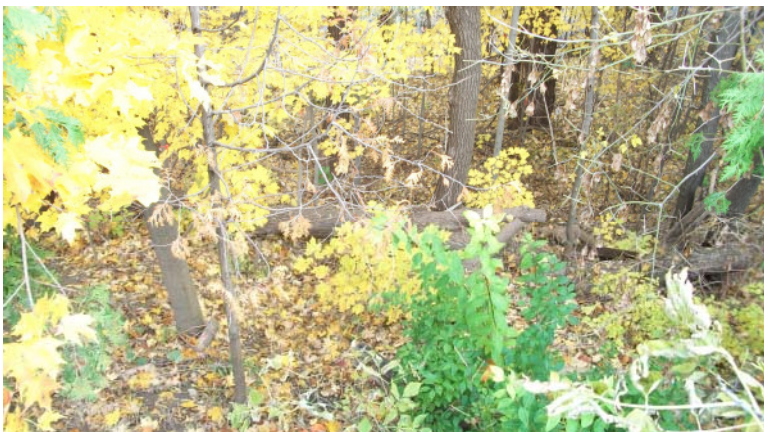
PHOTOGRAPH No.9
Slope face directly north of
39 Troutbrooke Dr., well
vegetated, looking north.

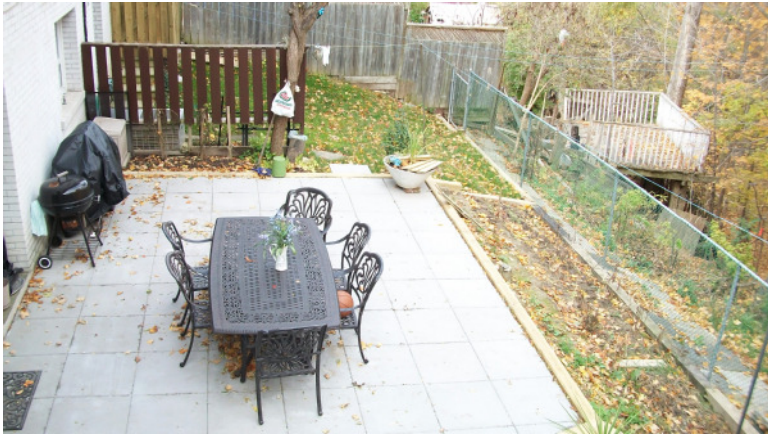
PHOTOGRAPH No.11
Tableland and slope crest of
41 Troutbrooke Dr., looking west.

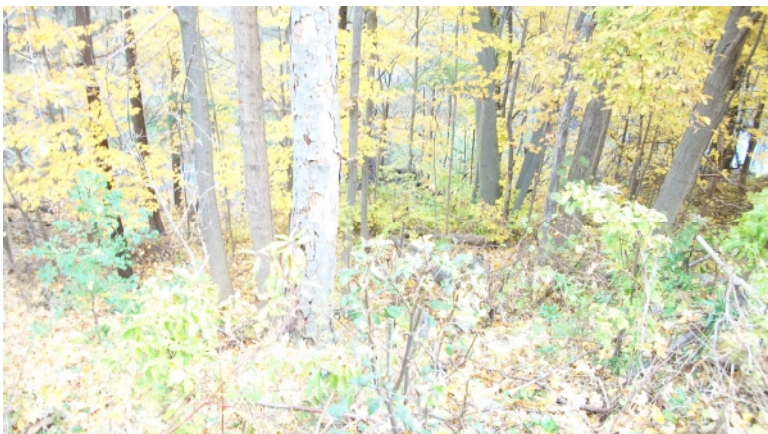
PHOTOGRAPH No.12
Slope face directly north of
41 Troutbrooke Dr., well
vegetated, looking north.
