APPENDIX A

Criteria & Implementation Procedures for Valley & Stream
Corridor Regeneration and Remedial Works Projects

PHOTOGRAPH LOCATION AND PHYSICAL FEATURES PLAN

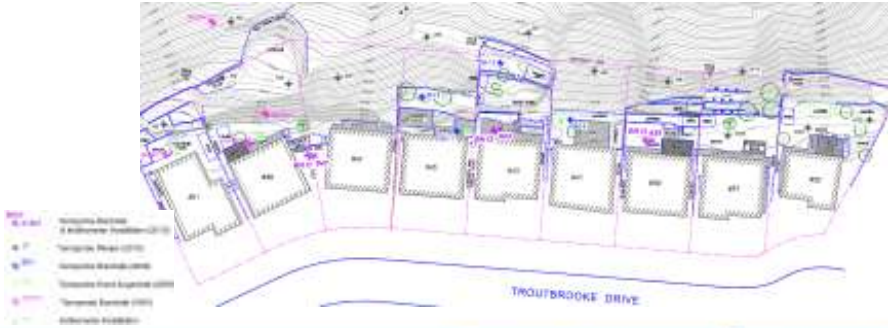
- Current Study: initiated late September 2010
- Three additional boreholes (I1 to I3) and inclinometers on table land between #49/47, behind 43 and 39. Now inclinometers at #51 to #39.
- Thirteen additional fill thickness boreholes (H1 to H13)

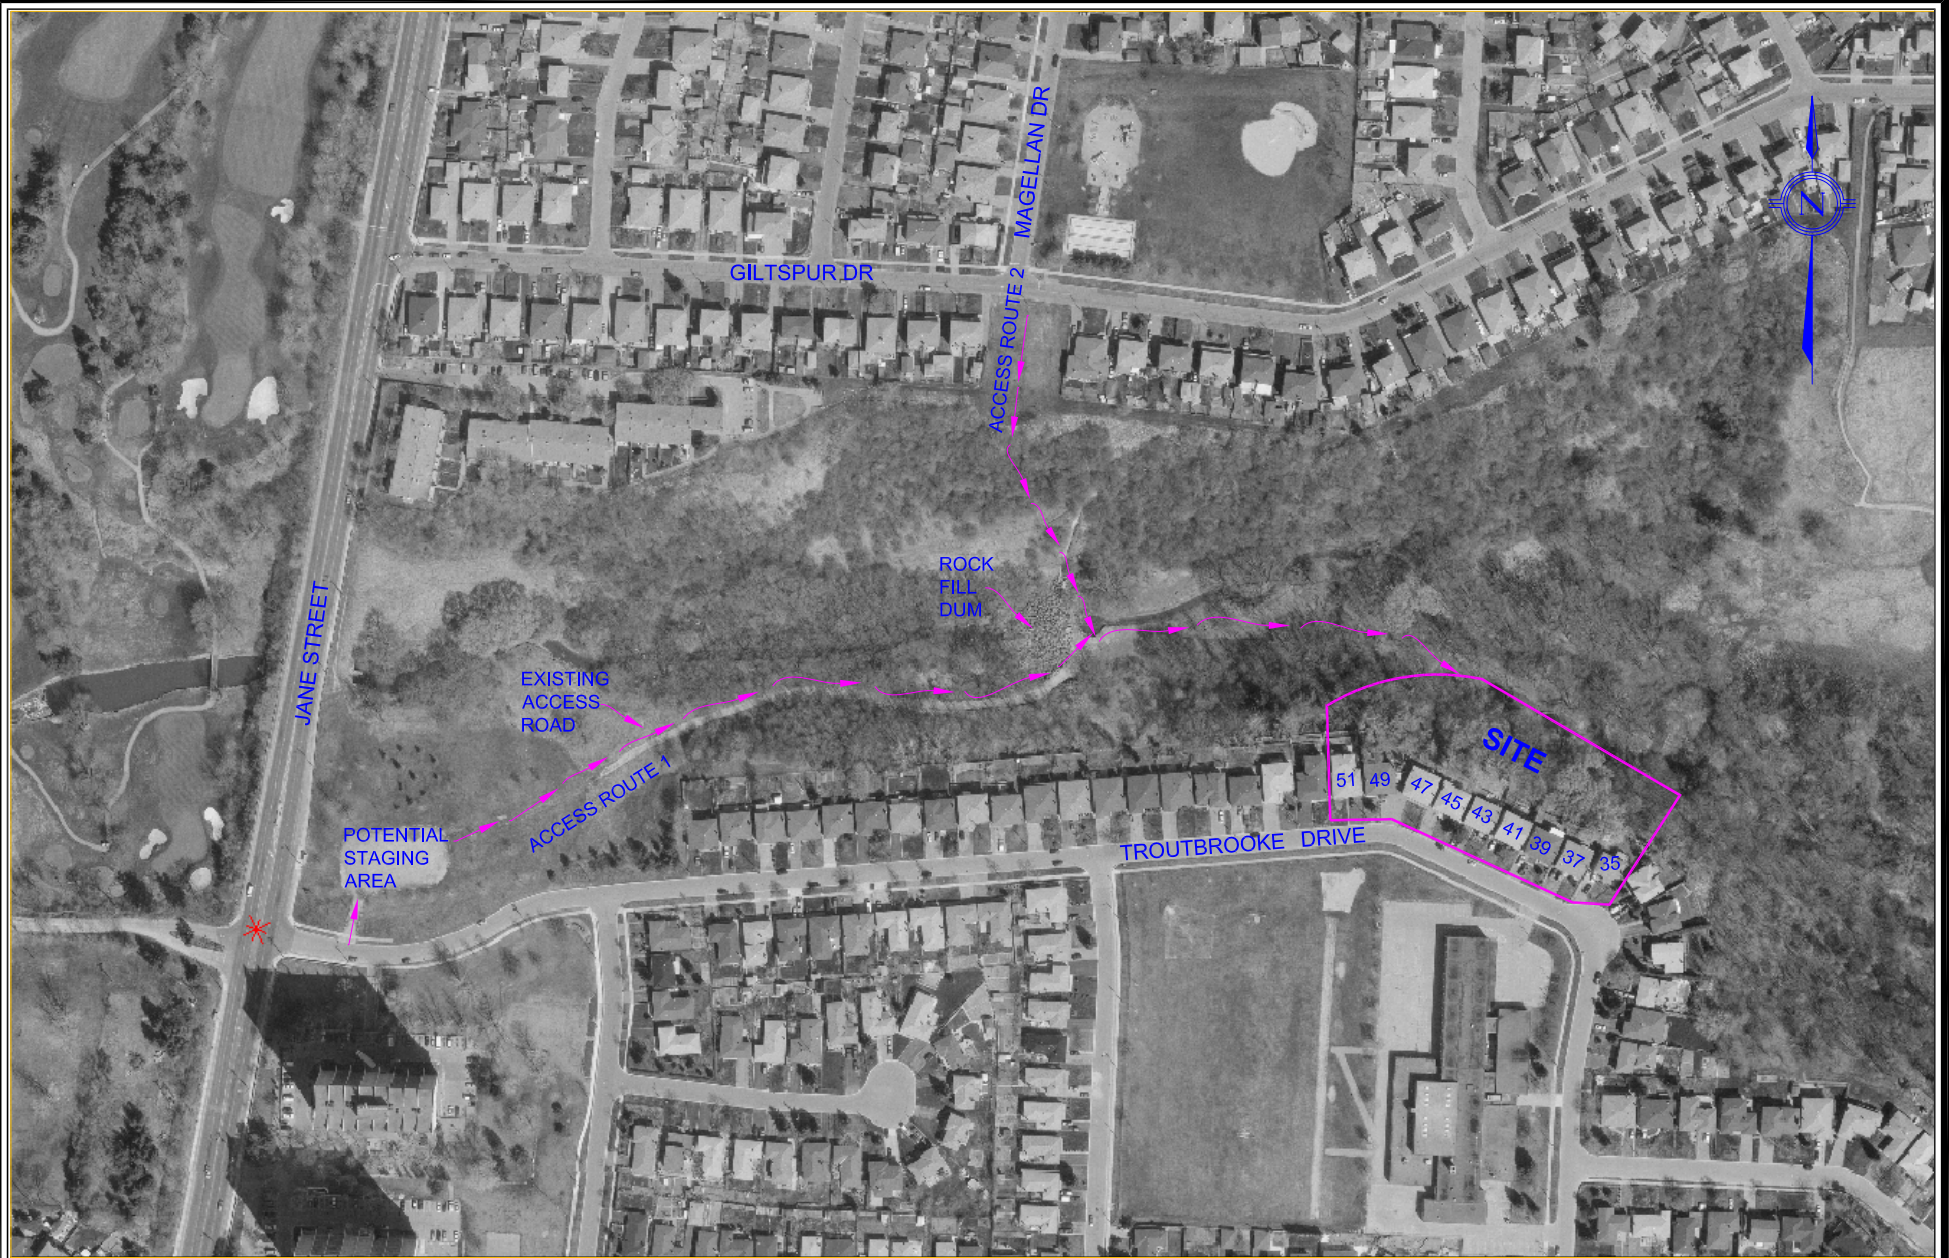
POTENTIAL ACCESS ROUTES

Access to the rear yard areas between the houses is not possible due to space limitations. Terraprobe investigated potential access routes for typical construction equipment required for the remediation recommended above. **Figure 7** presents two possible access routes.

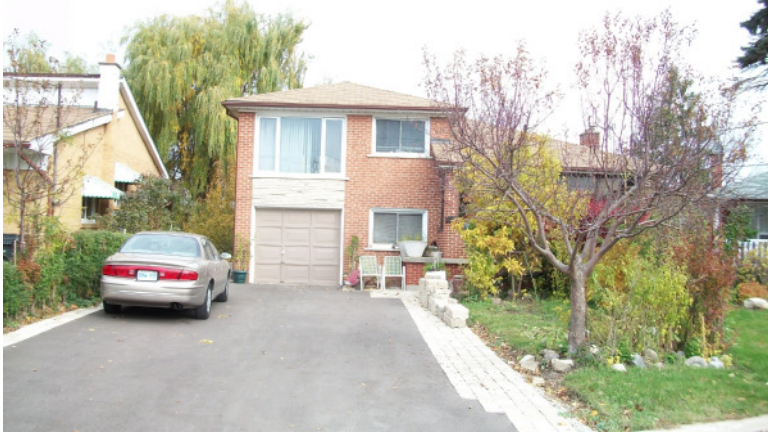
PHOTOGRAPH No.1

Front yard of 35 Troutbrooke Dr.,
looking north.

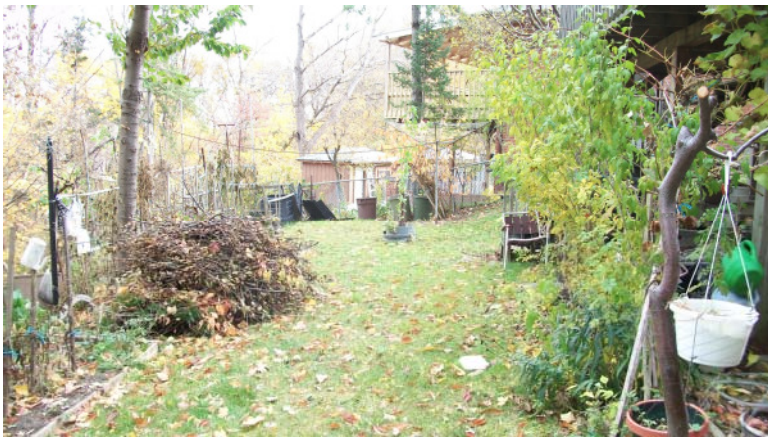
PHOTOGRAPH No.2

Tableland and slope crest of
35 Troutbrooke Dr., looking east.

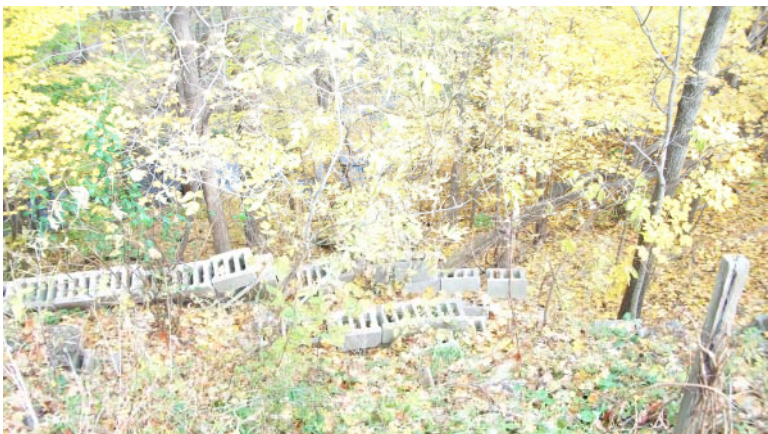
PHOTOGRAPH No.3

Slope face directly north of
35 Troutbrooke Dr., well vegetated,
looking north.

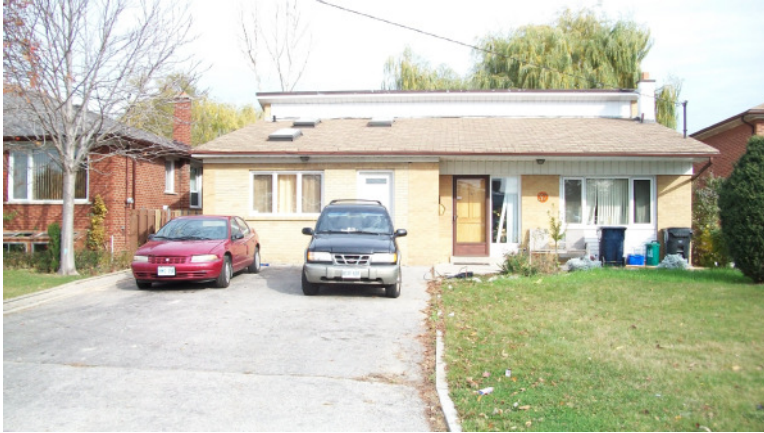
PHOTOGRAPH No.4

Front yard of 37 Troutbrooke Dr., looking north.

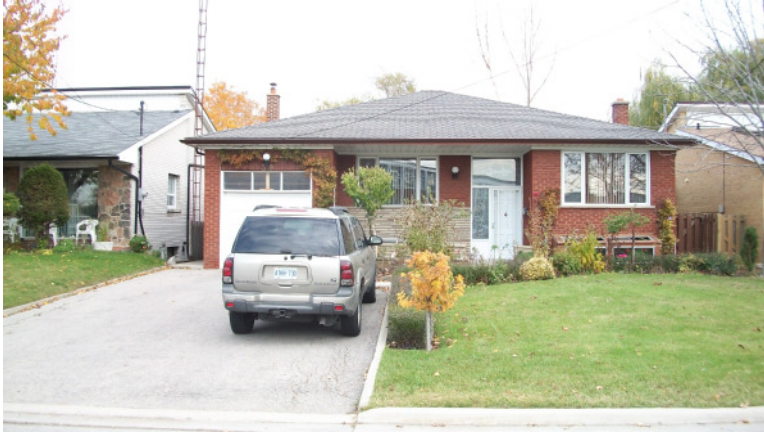
PHOTOGRAPH No.7
Front yard of 39 Troutbrooke Dr.,
looking north.

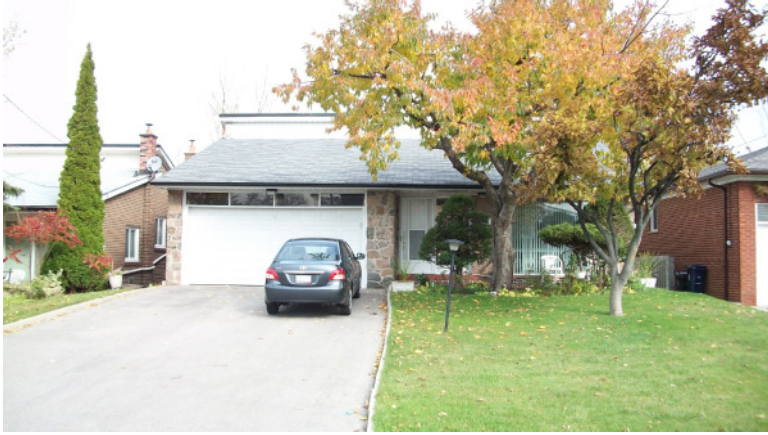
PHOTOGRAPH No.10
Front yard of 41 Troutbrooke Dr.,
looking north.

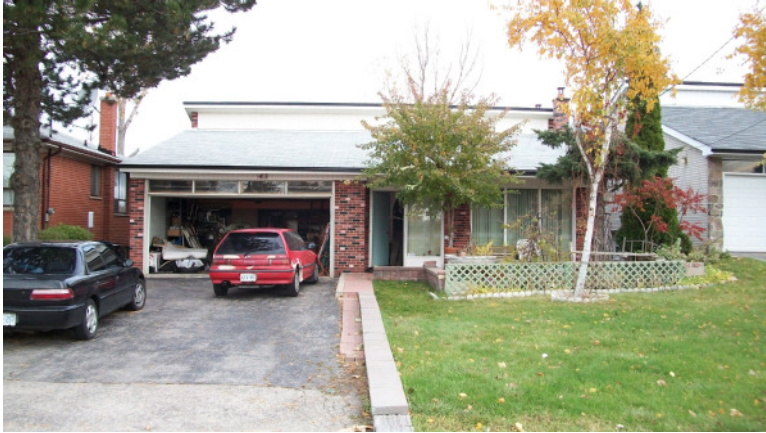
PHOTOGRAPH No.13

Front yard of 43 Troutbrooke Dr., looking north.

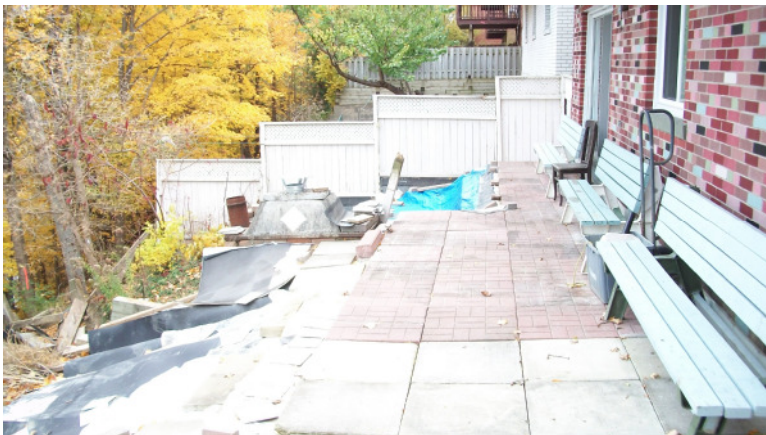
PHOTOGRAPH No.14

Tableland and slope crest of 43 Troutbrooke Dr., destruction of tableland due to slumping, looking east.

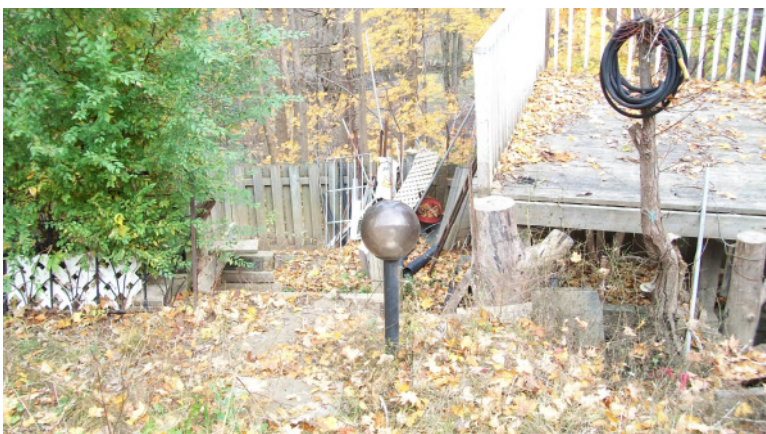
PHOTOGRAPH No.15

Slope face directly north of 43 Troutbrooke Dr., unusable deck and secondary scarp, looking north.

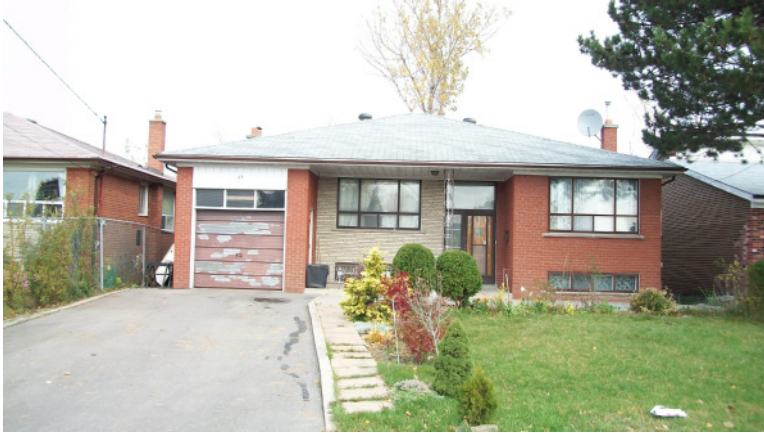
PHOTOGRAPH No.16
Front yard of 45 Troutbrooke Dr.,
looking north.

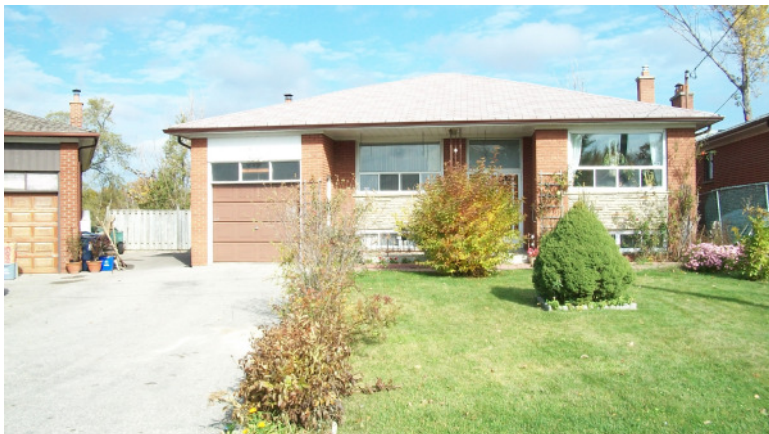
PHOTOGRAPH No.19

Front yard of 47 Troutbrooke Dr., looking north.

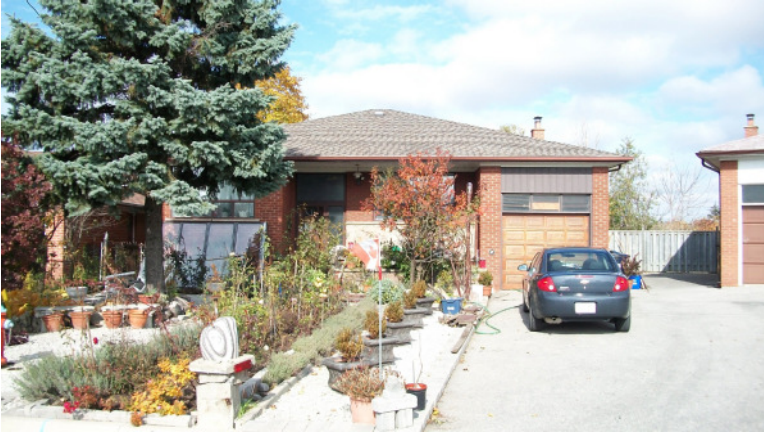
PHOTOGRAPH No.22

Front yard of 49 Troutbrooke Dr., looking north.

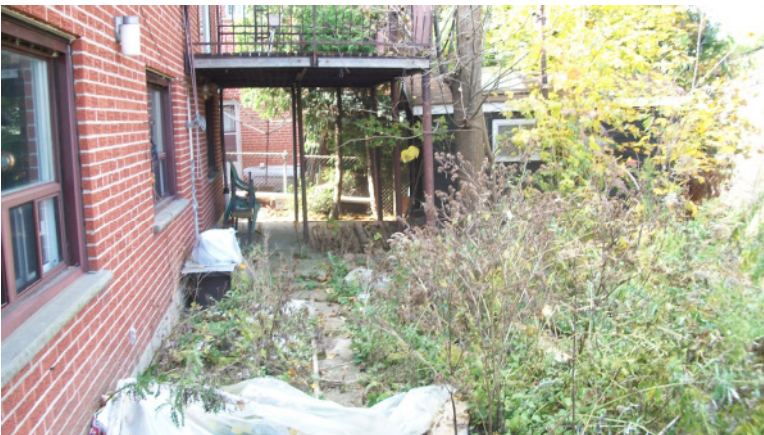
PHOTOGRAPH No.23

Tableland and slope crest of 49 Troutbrooke Dr., looking west.

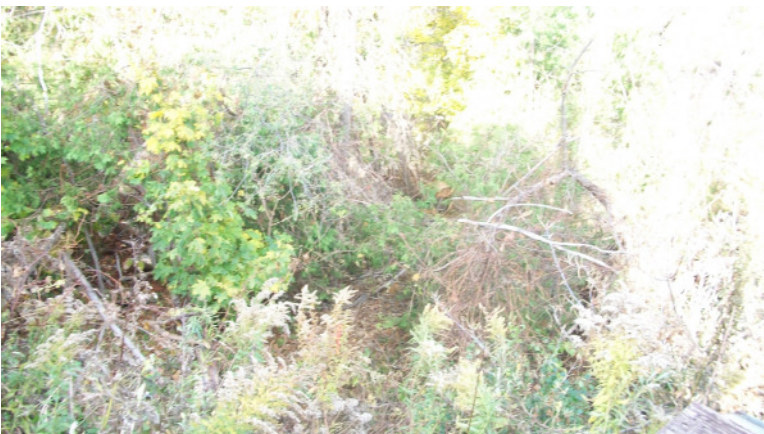
PHOTOGRAPH No.24

Slope face directly north of 49 Troutbrooke Dr., well vegetated, scarp crest, looking north.

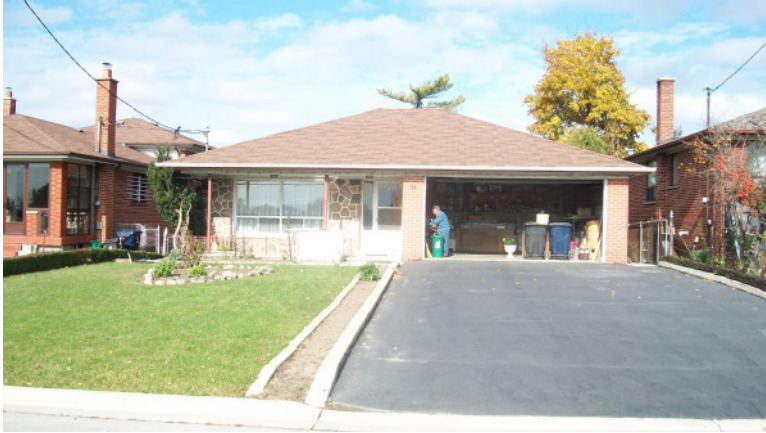
PHOTOGRAPH No.25

Front yard of 51 Troutbrooke Dr., looking north.

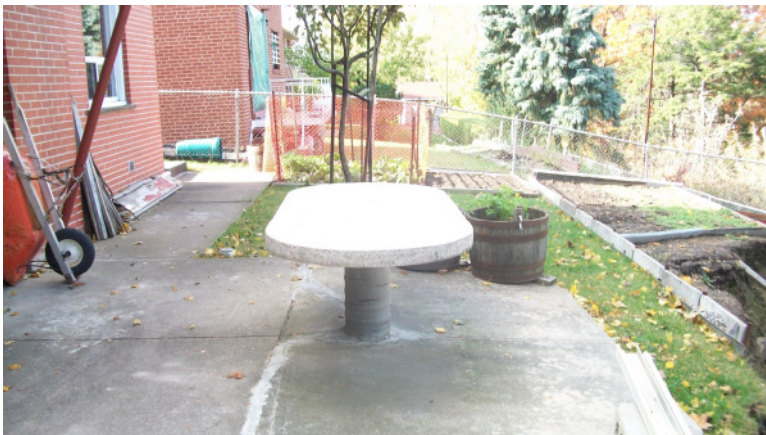
PHOTOGRAPH No.26

Tableland and slope crest of 51 Troutbrooke Dr., looking west.

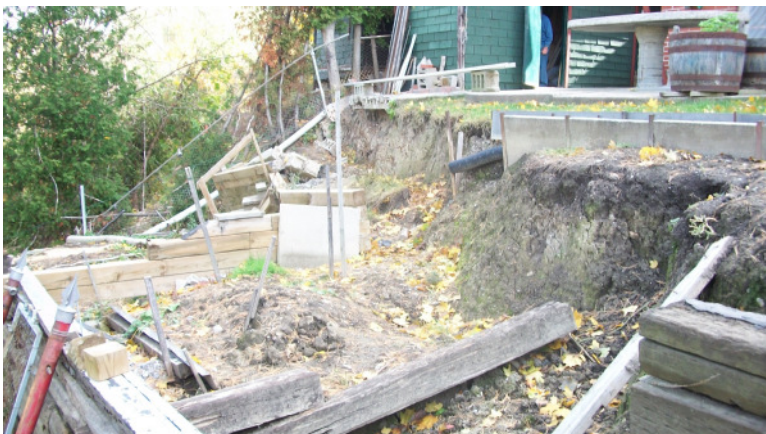
PHOTOGRAPH No.27

Scarp north of 51 Troutbrooke Dr., looking east.

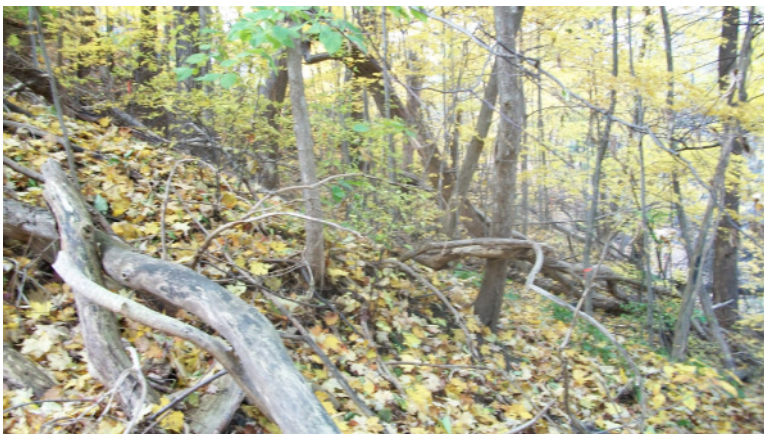
PHOTOGRAPH No.30

Below the upper filled areas, the slope face is generally well vegetated (Photograph 30). There are some less vegetated areas that exist due to the mature trees blocking much sunlight from reaching the ground. There are also some bare and oversteepened areas present due to both landscaping debris and minor scarps (Photograph 41). There are bent trees throughout the site (Photograph 32). The saplings are primarily straight with some slight bending while the more mature trees have a much more pronounced bending to them

Well vegetated slope face, looking west.

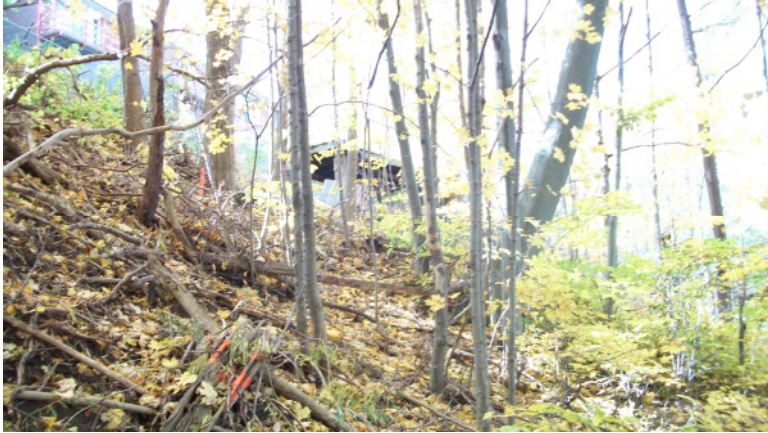
PHOTOGRAPH No.31

indicating the presence of both long-term creep and slope failures in the past (Photograph 31). Throughout the site, but primarily along the western portion of the slope, there is much garbage and landscaping debris. Directly behind #49 Troutbrooke Drive there is a high concentration of this garbage and debris (Photograph 37). There exist two very minor gullies with minimal erosion that extend down the entirety of the slope face (Photograph 38). The fences, retaining walls and structures associated with the residential houses also extend onto the upper portions of the slope, some of which are failing or compromised (Photograph 36). Across the slope face, isolated minor scarps were observed ranging from 0.3 m to 0.6 m (Photograph 39 to 40).

Well vegetated slope face with bent mature trees and relatively straight saplings, looking west.

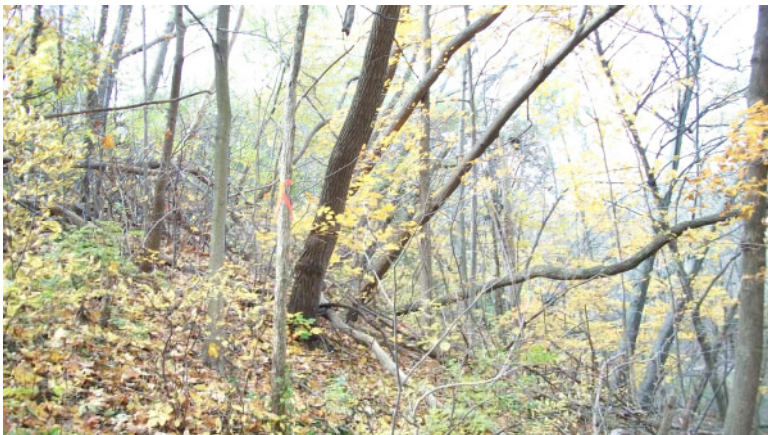
PHOTOGRAPH No.32

Well vegetated slope face with bent trees, looking west.

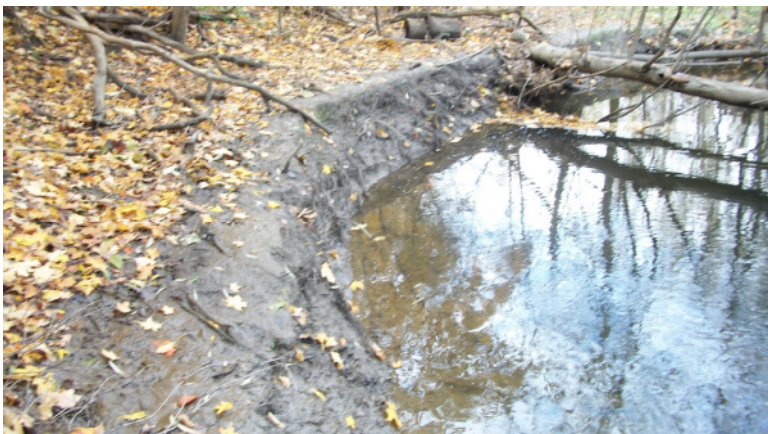
PHOTOGRAPH No.33

Slope toe adjacent to river, toe erosion causing 0.3m scarp and exposed roots, looking west.

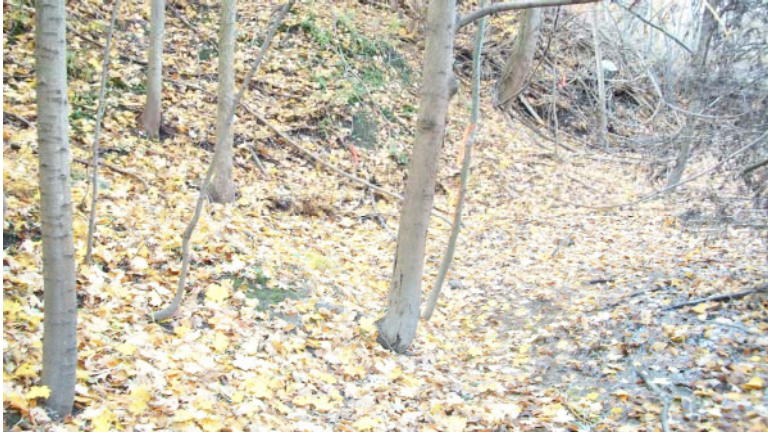
PHOTOGRAPH No.34

The slope toe is primarily adjacent to swampy and marshy ground, and due to this, there is no evidence of active toe erosion (Photograph 34 to 35). On the eastern portion of the slope, the slope toe is adjacent to a meander of Black Creek. The creek at the time of inspection at this eastern site location was approximately 5 m wide, about 0.5 m deep, and flowing very slowly at an estimated 0.05 to 0.2 m/s. This area is experiencing some active toe erosion and the toe has approximately 0.3m of exposed soil and roots (Photograph 33). The soil on the slope toe adjacent to the river appears to be silty clay, which is firm, dark brown and wet. Along the lower portion of the slope face and the slope toe, the slope is still well vegetated, and there is slightly less landscape debris and garbage present than the slope face.

Slope toe adjacent to marshy area, looking west.

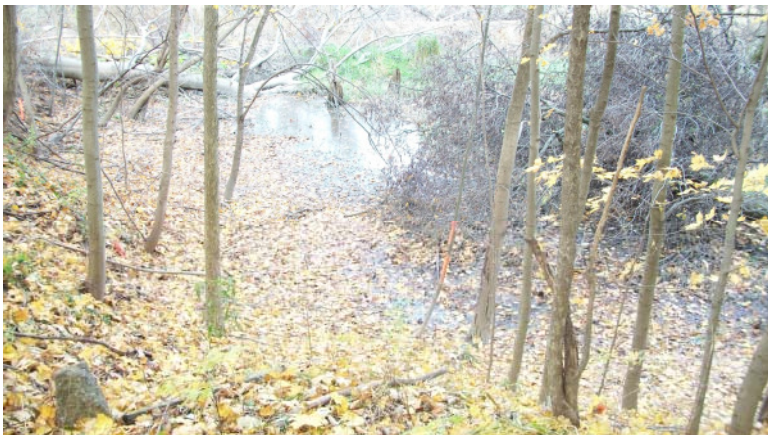
PHOTOGRAPH No.35

Marshy area adjacent to slope toe, looking northwest.

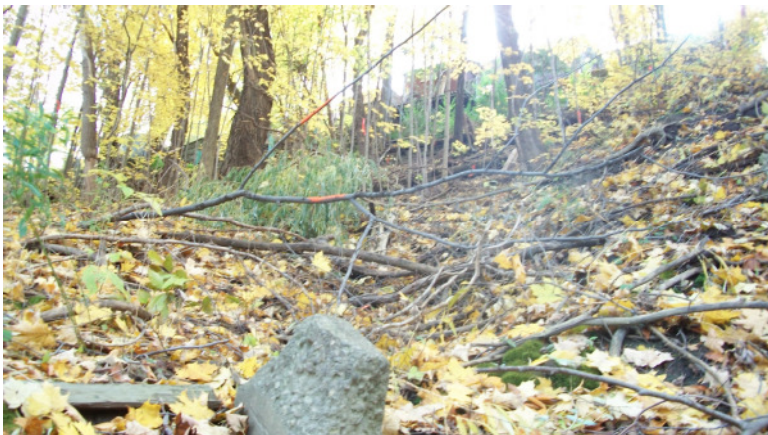
PHOTOGRAPH No.38

Minor gully on slope face, minimal erosion, looking southeast.

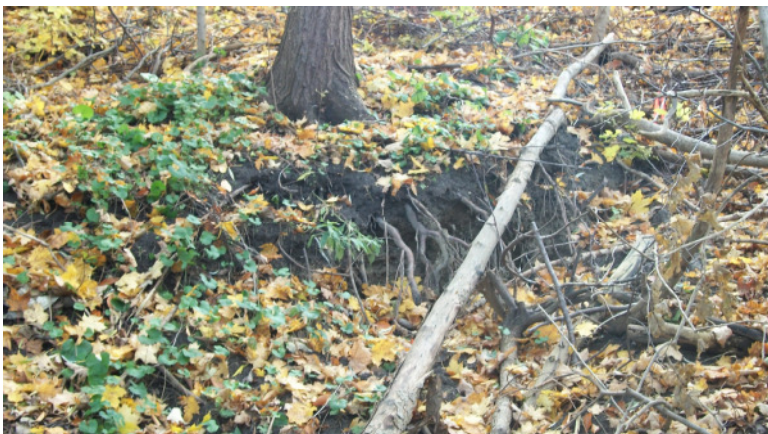
PHOTOGRAPH No.39

Minor (0.3m) scarp associated with eastern portion of site, looking south.

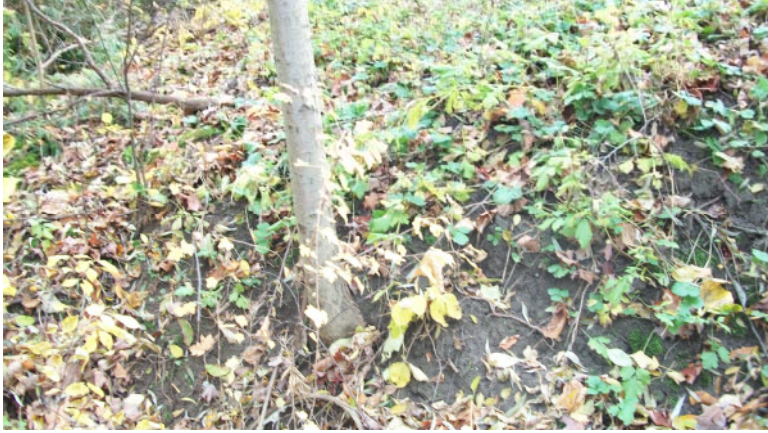
PHOTOGRAPH No.40

Minor (0.6m) scarp associated with western portion of site, looking south.

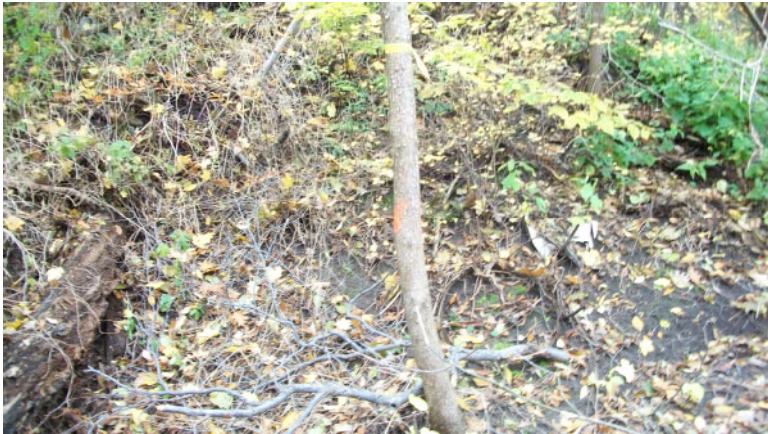
PHOTOGRAPH No.41

Bare and over steepened areas present, associated with both mature trees and landscaping debris/garbage, looking south.
